Manhole Inspection Summary

Manhole # S31GG1031MH

Insp Date: **12/8/06 2:37 PM**

Location Address: **UNIVERSITY PKWY**

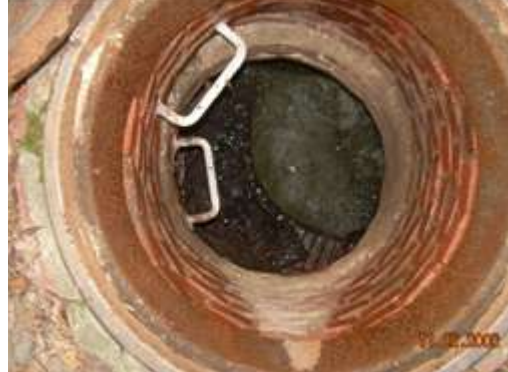
Top View

Frame leaks. Adjustment and Corbel infiltration. Bench debris.

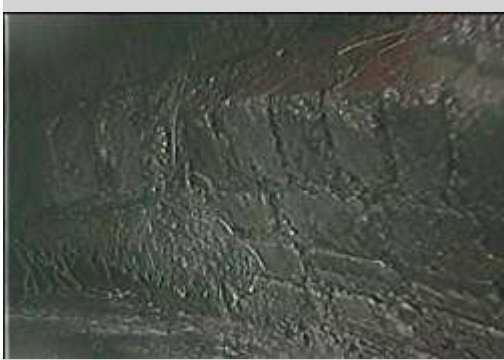
Defect

Barrel root intrusion and infiltration.
Channel deterioration and root intrusion.

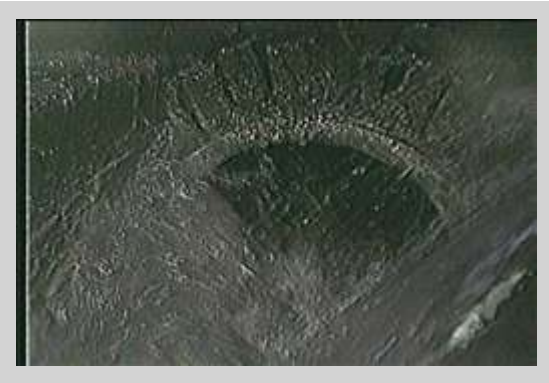
18 in. Circular Gravity Sewer Pipe Out @ 12 O'Clock

Infiltration: **None** Pipe Seal Cond: **Cracked**

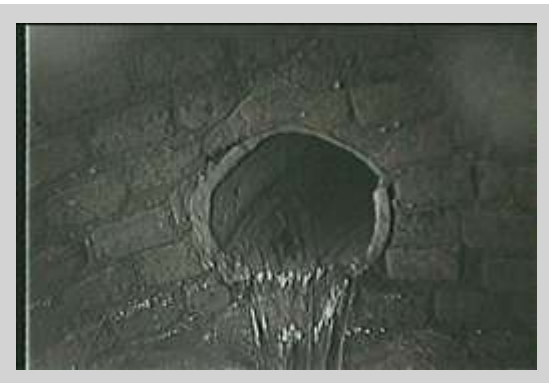
8 in. Circular Gravity Sewer Pipe In @ 2 O'Clock

Infiltration: **None** Pipe Seal Cond: **Broken**
